PROTECTING STILT BUILDINGS FROM DAMAGE DUE TO RAYLEIGH WAVES DURING LARGE MAGNITUDE EARTHQUAKES LOCATED AT DISTANCE FROM EPICENTER- CASE FROM INDIA

Arun BAPAT

Consulting Seismologist, India

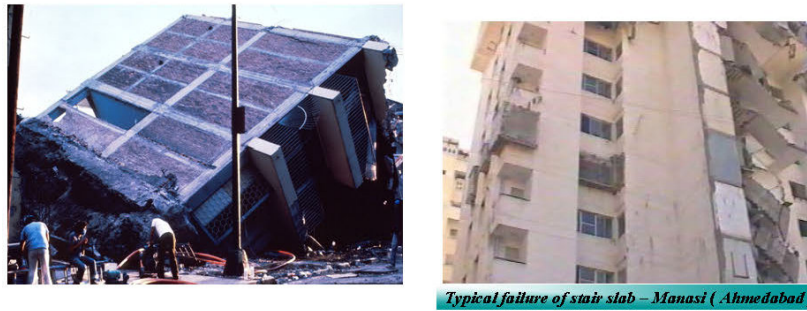
Damage at Mexico City

Typical failure of stair slab – Manasi (Ahmedabad)

Fig. 1. Damage to tall structures at Mexico (left), and damage at Ahmedabad (right).

For the first time such damage was observed at Mexico City during the 19 September 1985 earthquake of magnitude 8.0. The epicenter was located at a distance of about 530 km from Mexico City where only tall structures suffered heavy damages. In India, during the 26 January 2001 Bhuj earthquake of $M = 7.9$, damage to tall structures was observed. The Ahmedabad City is located at a distance of about 320 km from the Bhuj earthquake epicenter. In Ahmedabad tall structures have suffered heavy damages. But there was some new observation. This was damage to stilt structures of two or three storey. **Fig. 1** shows damage to tall structure. While **Fig. 2 (a), (b) and (c)** shows damages to stilt floor structures at Ahmedabad. All structures in **Fig. 2 (a), (b) and (c)** are two / three storey.

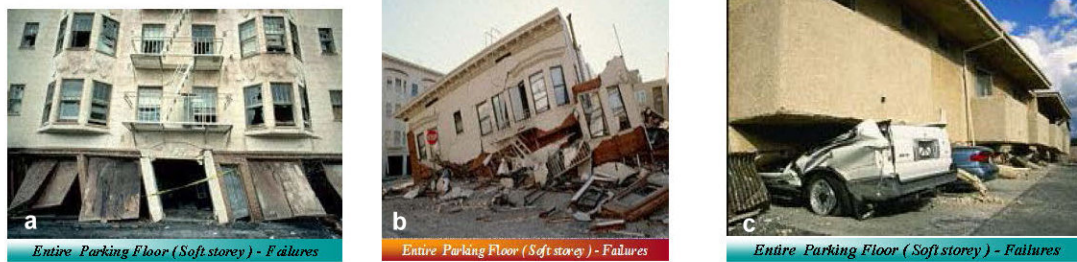
Fig. 2. Damages of structures with stilt structure: Left (a), three storey, center (b) two storey, and right (c), damage to a parking lot.

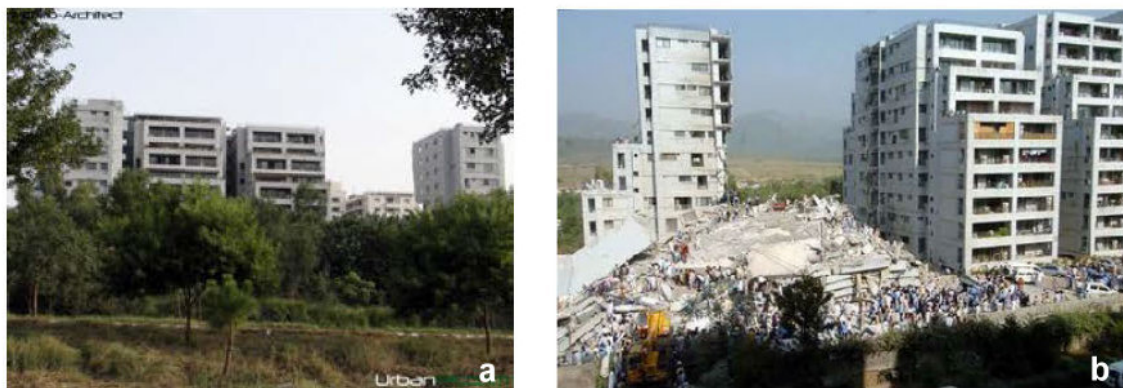
Margala Tower on right before collapse

Margala Tower in Islamabad collapses after the 7.9 magnitude earthquake.

Fig. 3. Margala Tower in Pakistan before earthquake, left figure, and after earthquake, right.

The $M = 8$ earthquake of 08 October 2005 in (Pakistan) had severely damaged a tall building Margala

Towers at Islamabad situated at distance of about 150 km from the epicenter. **Fig 3(a)** and **Fig. 3 (b)**

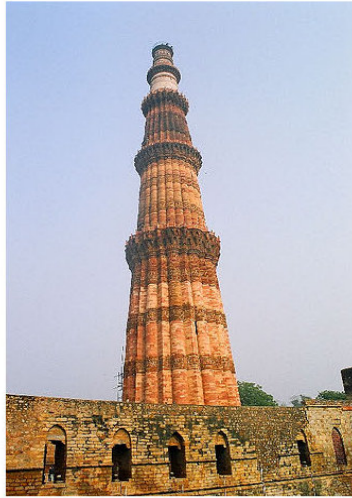
During 01 Sept, 1803 earthquake, two upper floors of Qutab were dislodged. This was repaired subsequently.

Fig. 4. Qutab Minar a 72.5 m tall minaret at Delhi. The upper two floors were dislodged during an earthquake in 1803. This was subsequently repaired.

During 01 September 1803 earthquake in NW Himalayas, the upper two floors of the 72 m high Qutab Minar were dislodged. This is due to Rayleigh Waves. This has been mentioned on a marble plaque on the inner staircase. The damage was subsequently repaired. See **Fig. 4**.
